Saturn Bm Marine
Class 2

Technical Manual

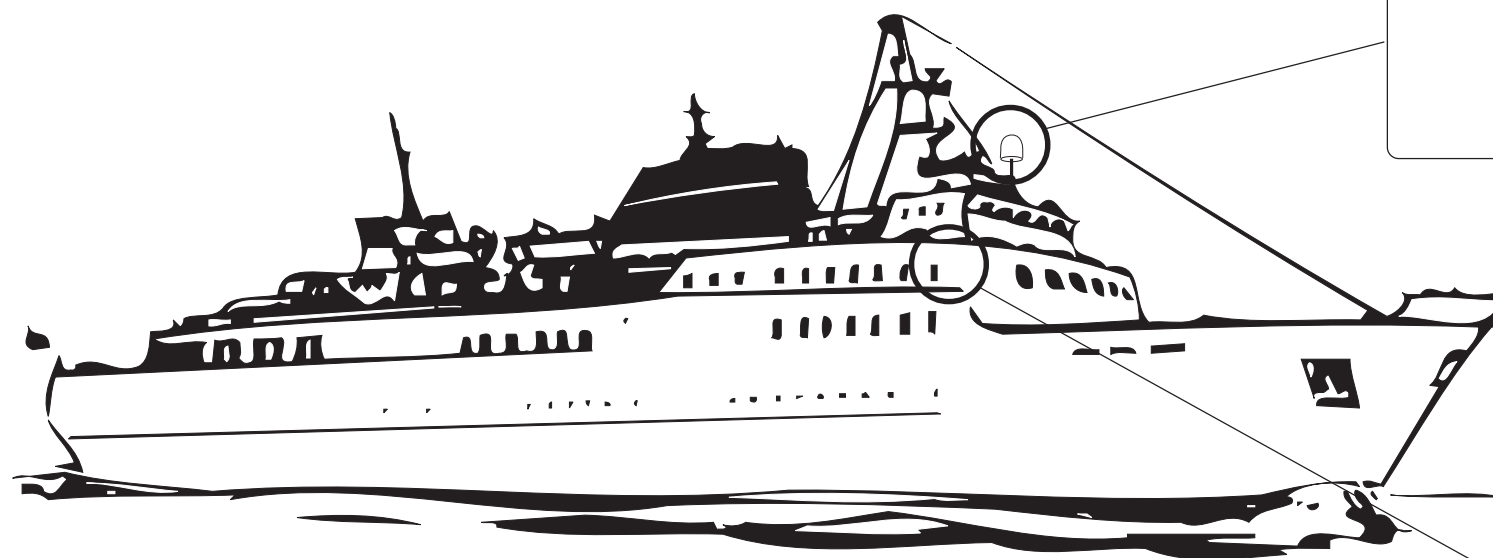
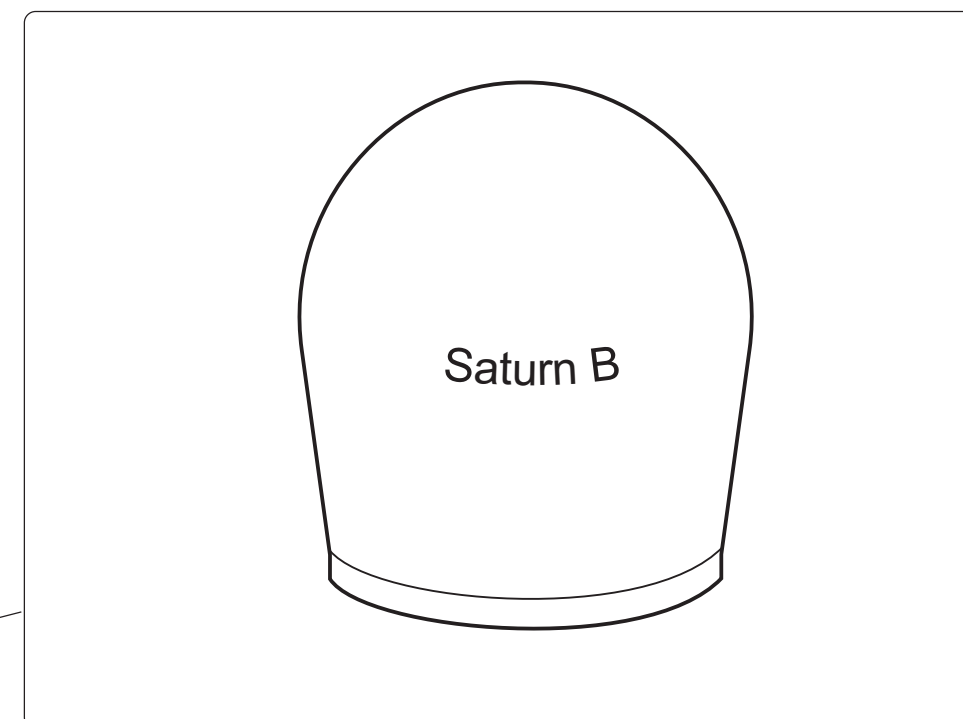
The Saturn Bm Mk2 Above Deck Equipment (ADE) is protected by a radome, and it is mounted on a mast to avoid possible obstructions. Obstructions will cause blind spots, with the result of signal degradation or even loss of communication with the satellite.

The ADE should also be separated as far as possible from the HF antenna, and preferably by at least 5 m from the antennas of other communication or navigation equipment.

Neither must the ADE be placed behind the funnel, as smoke deposits then eventually will degrade the antenna performance.

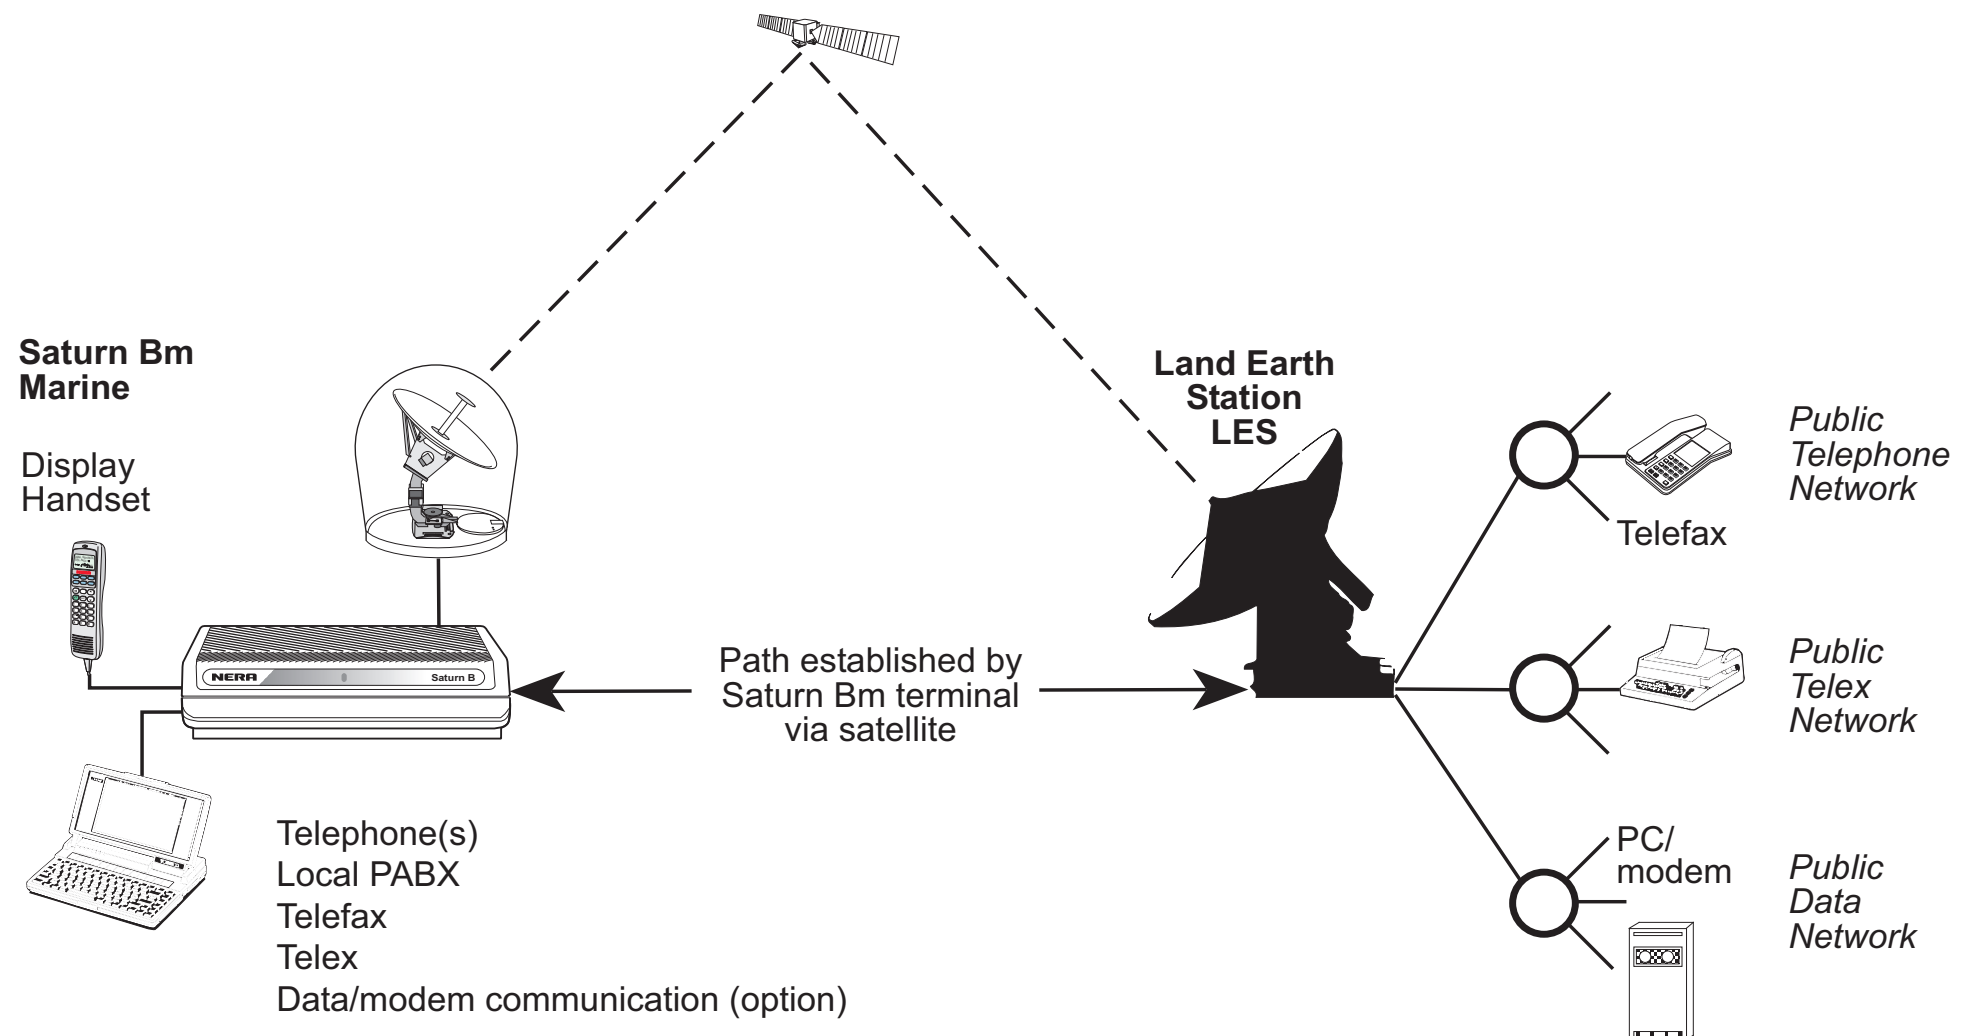
Figure 3.
Communication path.

The data service allows the Saturn Bm user to communicate at up to 56/64 kbps, via the public switched network, to fixed modems and data terminals.

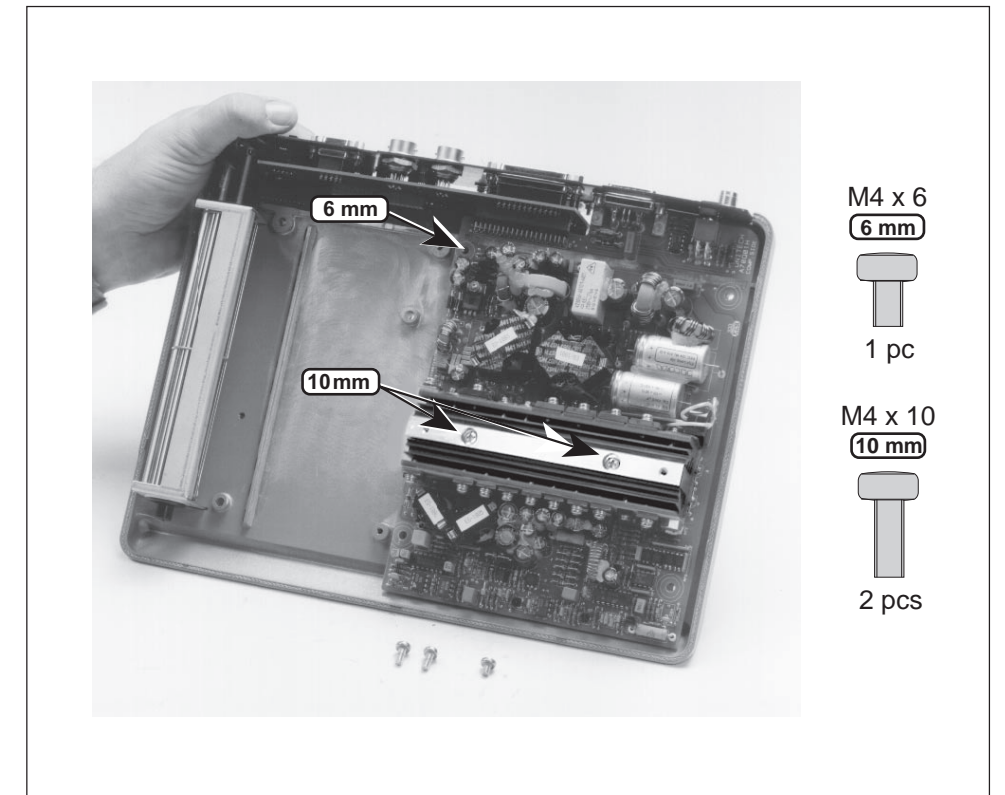
- Remove the screws fastening the Power Board.
Note! 3 screws – 2 sizes (6 mm/10 mm). See figure!
- Lift the front end of the circuit board and disengage it carefully from the edge connector.

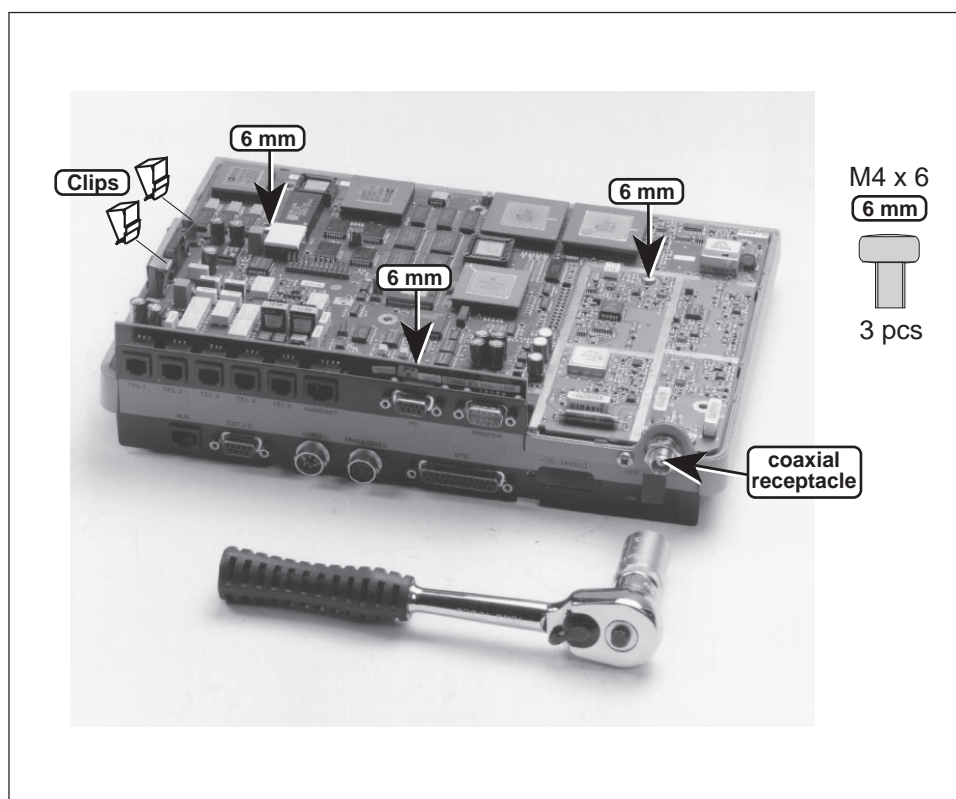
- Remove the screws fastening the Main Control Board
Note! 3 screws - 6 mm. See figure!
- Remove the clips pressing the IC against the cooling plate.
Note! Save the Sil pads.
- Unscrew the coaxial receptacle.
Note! 3/8" wrench. Nut and lock washer.

- Mount the Main Control Board
Note! 3 screws - 6 mm. See figure!
- Mount the coaxial receptacle.
Note! Nut and lock washer. 3/8" wrench.
- Replace the clips.
Note! Insert a sufficient amount of Sil pads so as to avoid tension on the IC.

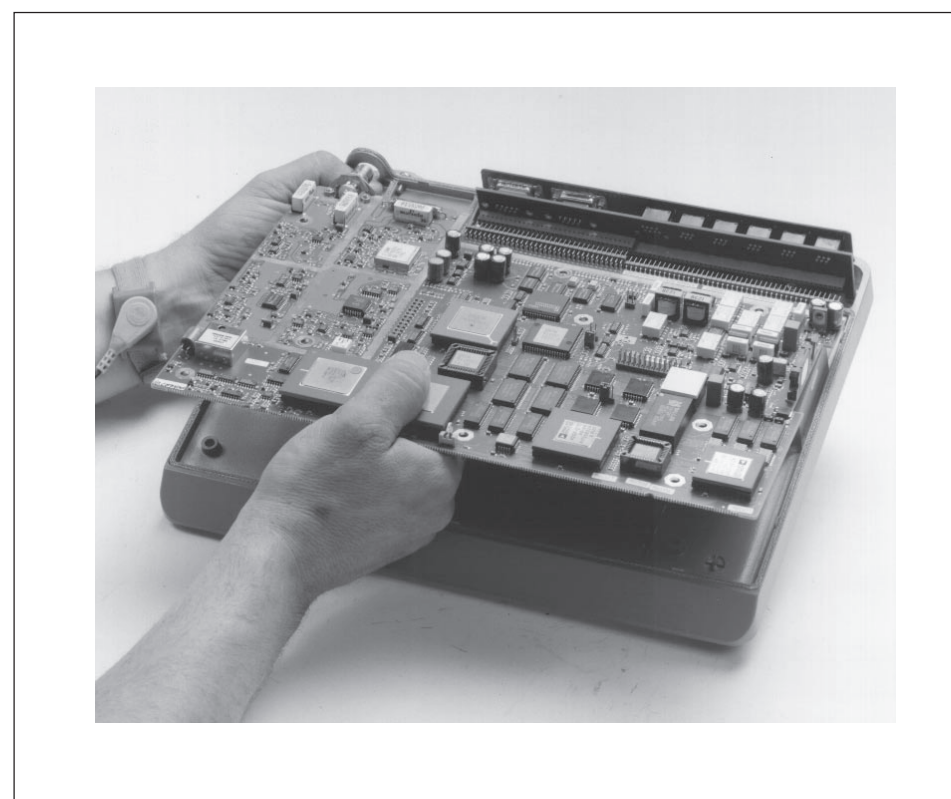
- Lift the front end of the circuit board and disengage it carefully from the edge connector.

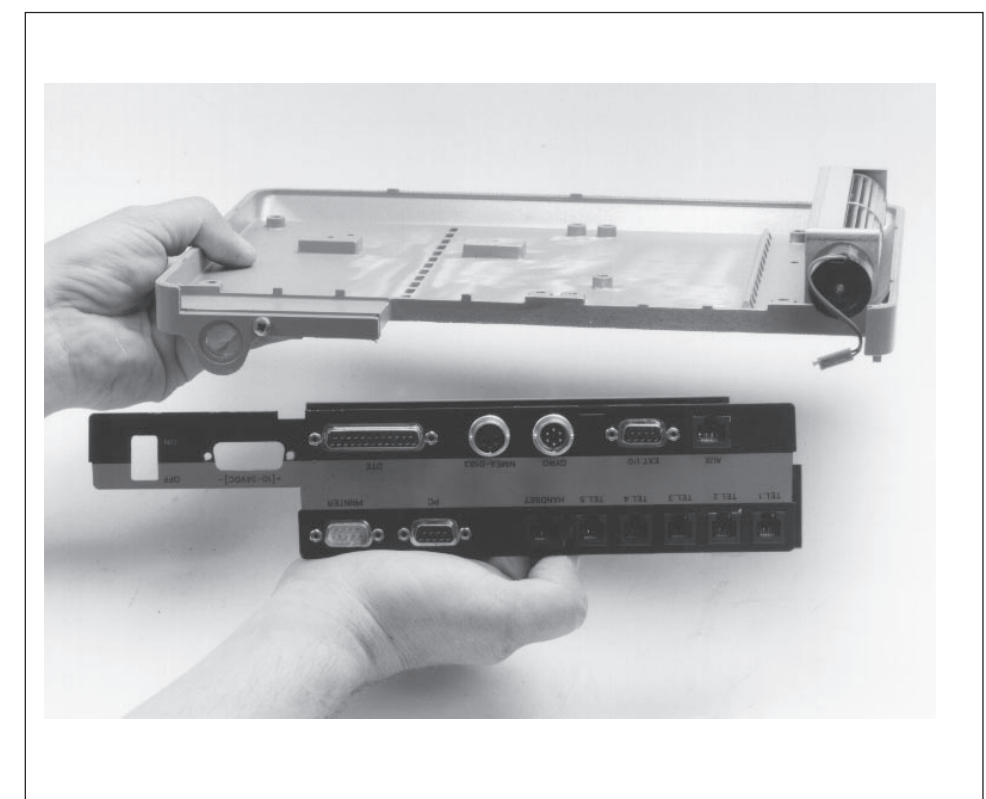
- Disconnect the fan wire plug.
The Connector Board is now loose and can be removed.

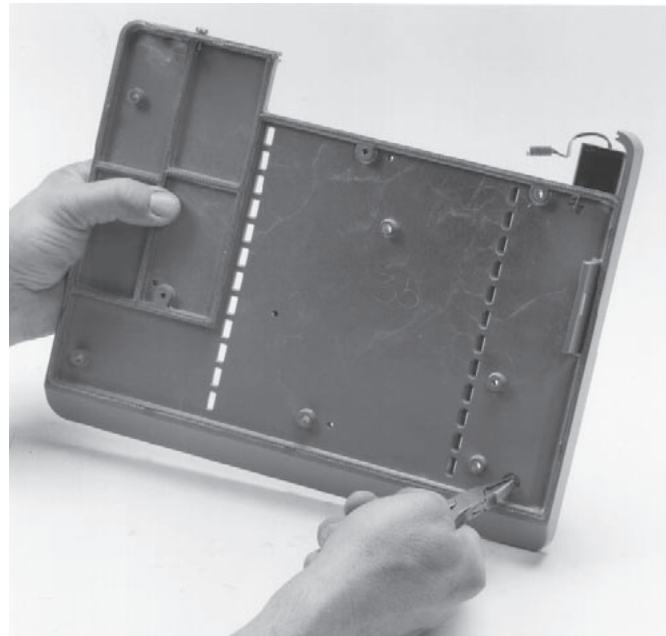
- Straighten the lugs fastening the fan assembly.
- Pull off the fan assembly

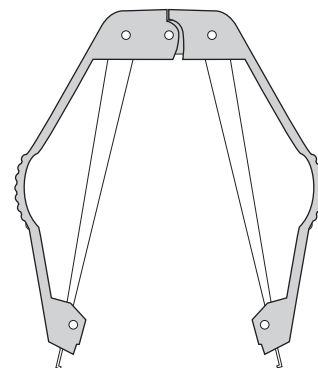
PLCC Extractor

- PLCC extractor
- Wrist strap
- Follow the instructions in steps 1 and 2 of the dismantling procedure.
- Locate the DSP PROM
- Place the PLCC extractor diagonally over the PROM as shown in the figure.
- Carefully pull up the PROM from the socket.

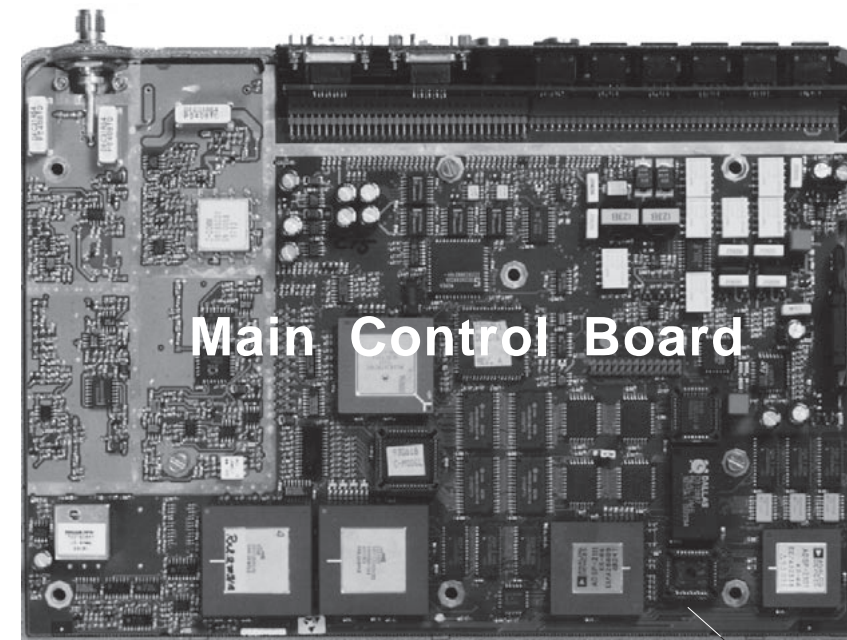
Main Control Board

DSP PROM

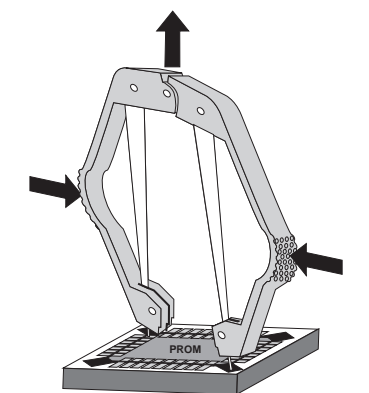
Extraction of DSP PROM

Slanted corner

- **Align the PROM** as shown in the figure and push it carefully down into the socket.
Note position of the slanted corner as shown!
- **Continue from step 5 of the mounting procedure.**

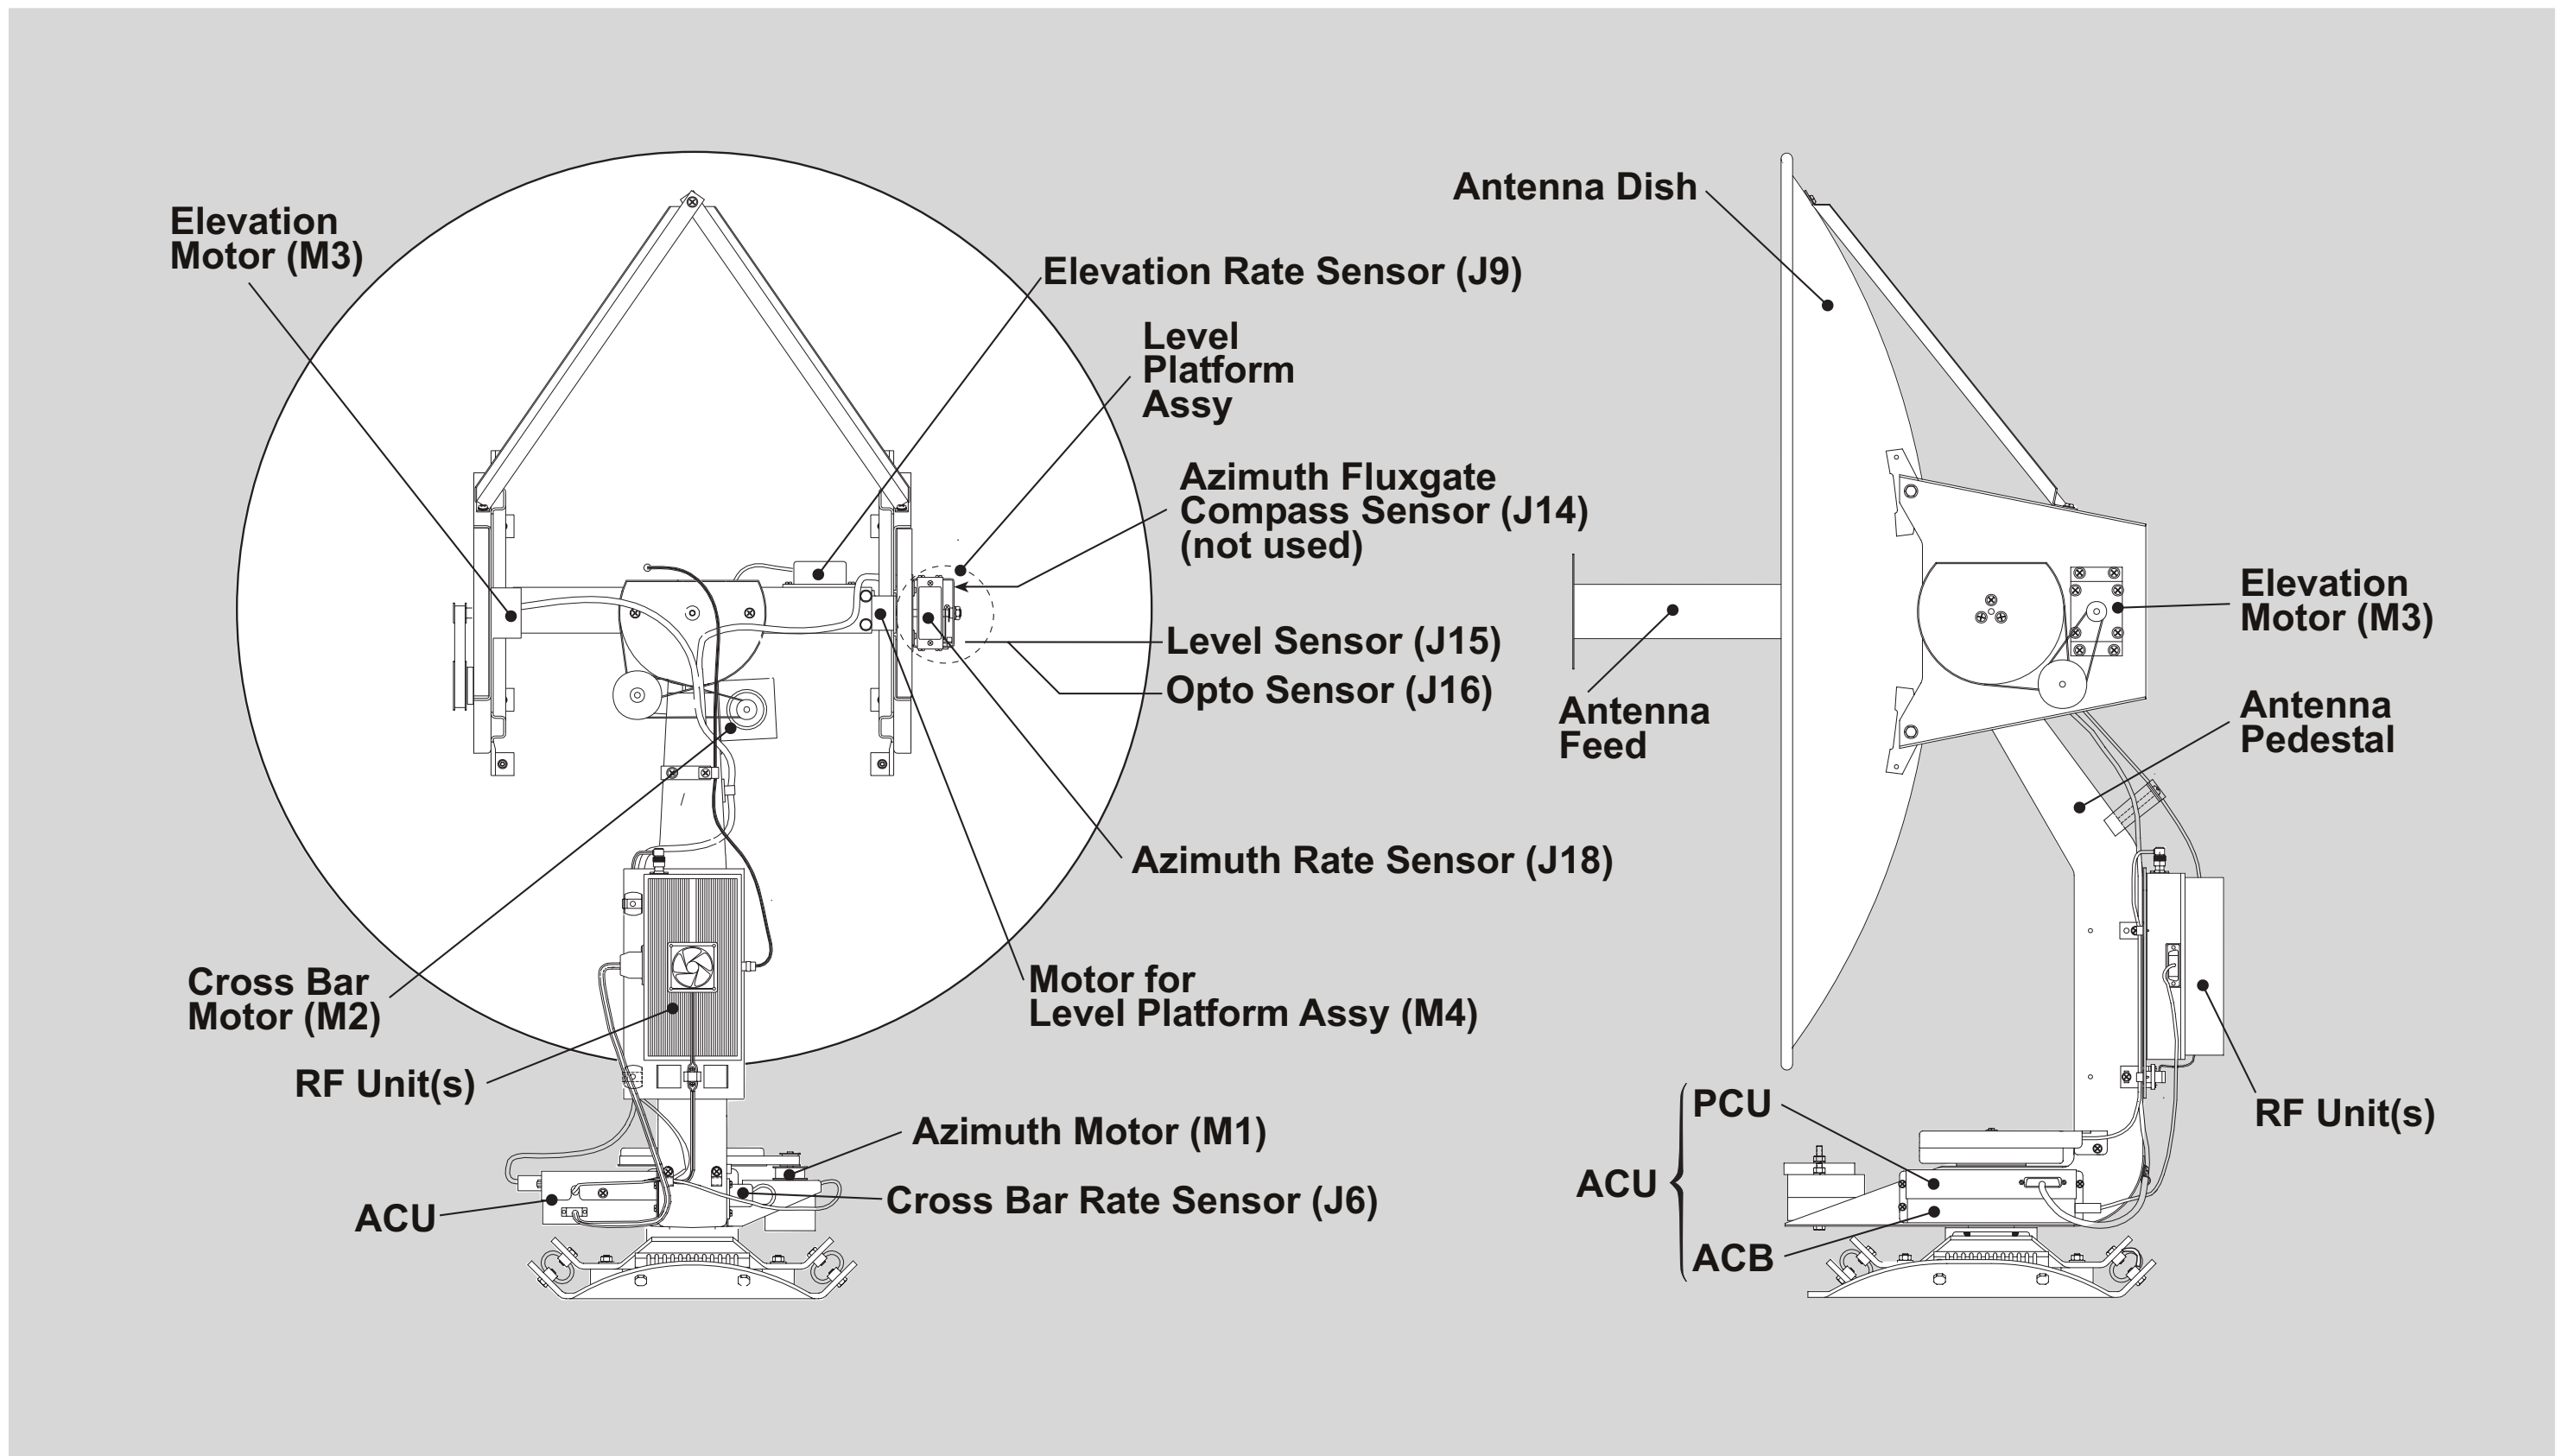
Above Deck Equipment

All devices contained in the "Above Deck Equipment" (ADE) are mounted on a pedestal and placed inside a glass fibre radome for protection. The devices include:
